Assessment of Highway Pavement Failure in Sedimentary Terrain Using Two-Dimensional Electrical Resistivity Tomography along Benin-Akure Expressway, Edo State, Nigeria

N. ENOMA and S. O. WILKIE

Department of Mineral and Petroleum Resources Engineering, Edo State Polytechnic, Usen, Edo State

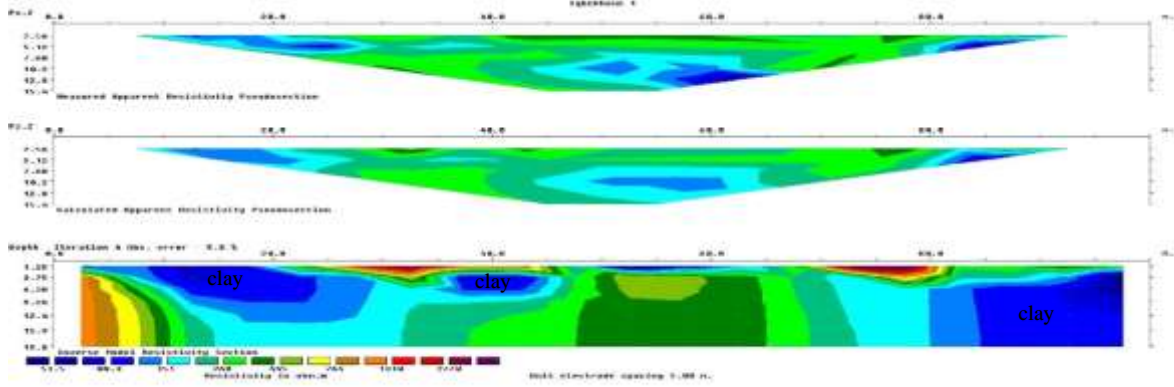
Figure 2a: 2D model of profile 1 at Igbekhowe

At Igbekhowe, for survey profile 1 (Figure 2a), the survey length is 100 m. At a distance of 2.0 m to 23.0 m, to a depth of 19.8 m, with resistivity range from 51.5 Ωm to 151.0 Ωm probably indicating formation of clay, clayey sand / sandy clay was observed while clay deposit with resistivity slightly above 51.5 Ωm is observed within the sand formation from a depth range of 3.75 m to 6.38 m at distance of 35 m to 45 m. At distance of 80 m and above, to a depth of 3.75 m, sand formation was also observed having resistivity value of 151 Ωm .

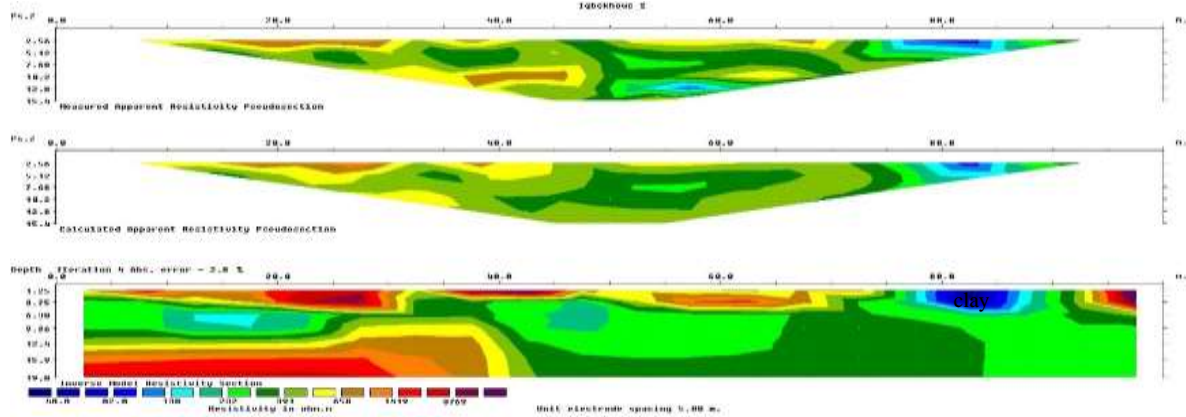
Figure 2b: 2D model of profile 2 at Igbekhowe

Survey profile 2, Figure (2b), at the distance of 75 m to 87 m along the surface to a depth of 6.38m, clayey sand formation was observed with resistivity range of value from 48.8 Ωm to 135 Ωm . These clay and sand formation may have also contributed to the road failure at this study location.

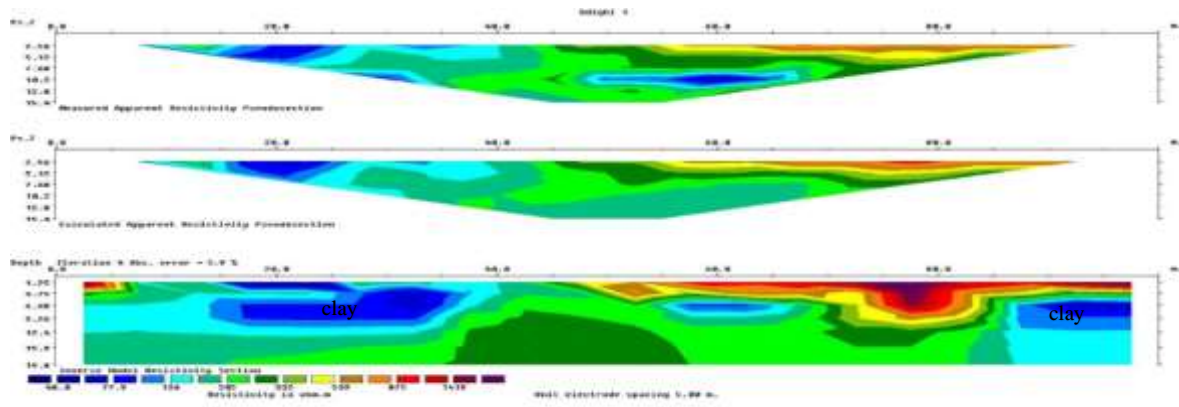
Figure 3a: 2D model of profile 1 at Odighi

Figure 3a shows the model of survey profile 1 at Odighi. At a surface distance of 10 m to 40 m along the length of the profile to a depth of 12.4 m from the surface, with resistivity value $40 \Omega\text{m}$ probably indicate clay formation, while a formation of sandy clay having resistivity ranging from $40.0 \Omega\text{m}$ to $205 \Omega\text{m}$ was observed between 85 m and above along the same profile length to a depth of 19.8 m.

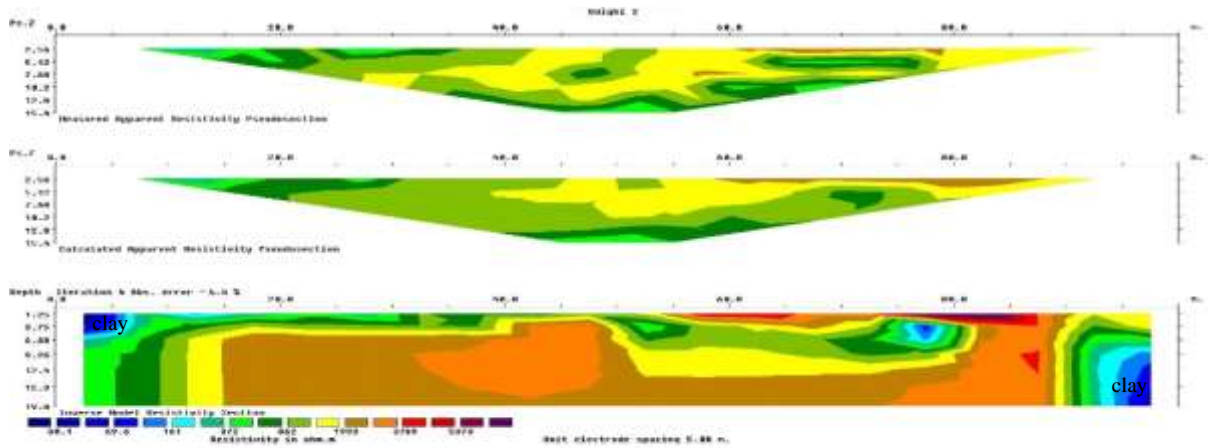
Figure 3b: 2D model of profile 2 at Odighi

Figure 3b also shows the model of survey profile 2 at Odighi. Clay formation can probably be found at a surface distances from 0 m to 5 m and 95 m to 100 m at depth of about 0 m to 6.38 m and 6.38 m to 19.8 m respectively from the surface having resistivity range from $30.1 \Omega\text{m}$ to $161 \Omega\text{m}$, and sandy sediments are found under the clay at 0 m to about 80 m, along the profile at depth 6.38 m from the top soil with the resistivity range $161 \Omega\text{m}$ to $372 \Omega\text{m}$.

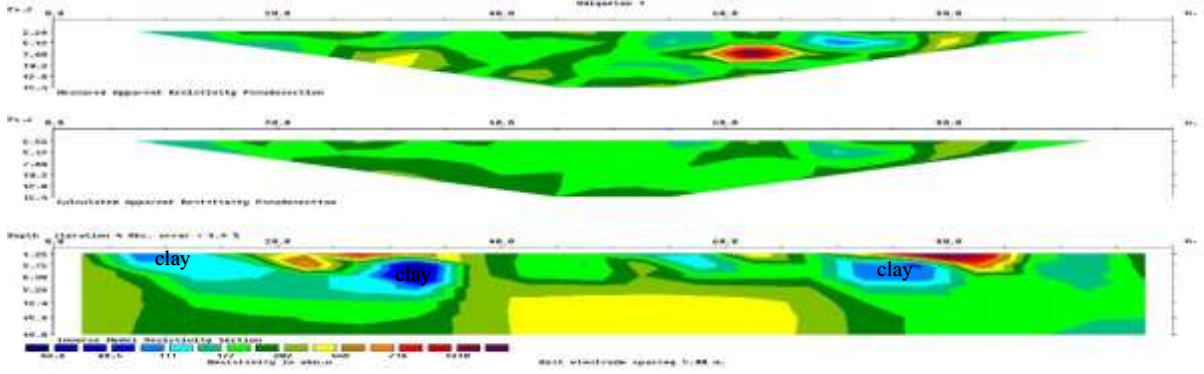
Figure 4a: 2D model of profile 1 at Odiguetue

Figure 4a shows the model of survey profile 1 at Odiguetue community, there is also a relatively low resistivity range of 43.6 Ωm to 111 Ωm at surface distance of 5m to 35m to a particular depth of 9.26m from the top soil. This was found to be probably clay mixed with sand. There is also, clay presence at depth of 3.75 m to 9.26 m and resistivity interval 43.6 Ωm to 177 Ωm , from 66 m to 80 m position along the profile. Below this formation, a layer of high resistivity (282-449) Ωm of sandy formation is present.

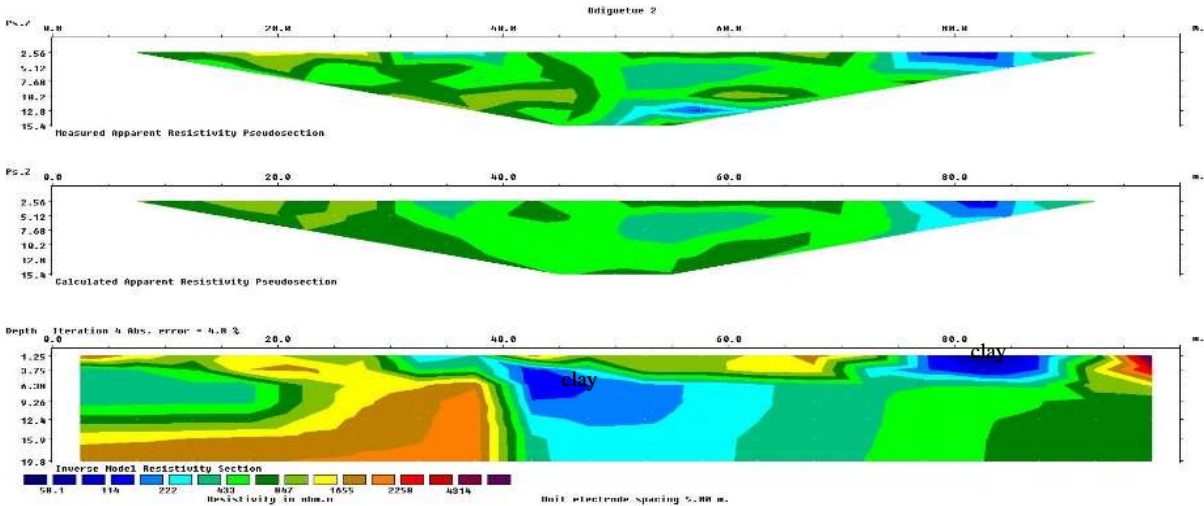
Figure 4b: 2D model of profile 2 at Odiguetue

Figure 4b also shows the model of survey profile 2 at Odiguetue. From distance 0 m to 20 m lateral length, is a portion of resistivity which ranges from 222 Ωm to 433 Ωm . This is observed to be probably sandy formation. From 40 m to 90 m length along the surface to a particular depth of 19.0 m from top, is a low resistivity with range of values from 58.1 Ωm to 222 Ωm . This can be the result of well compacted clay formation which can also influence the road's instability.

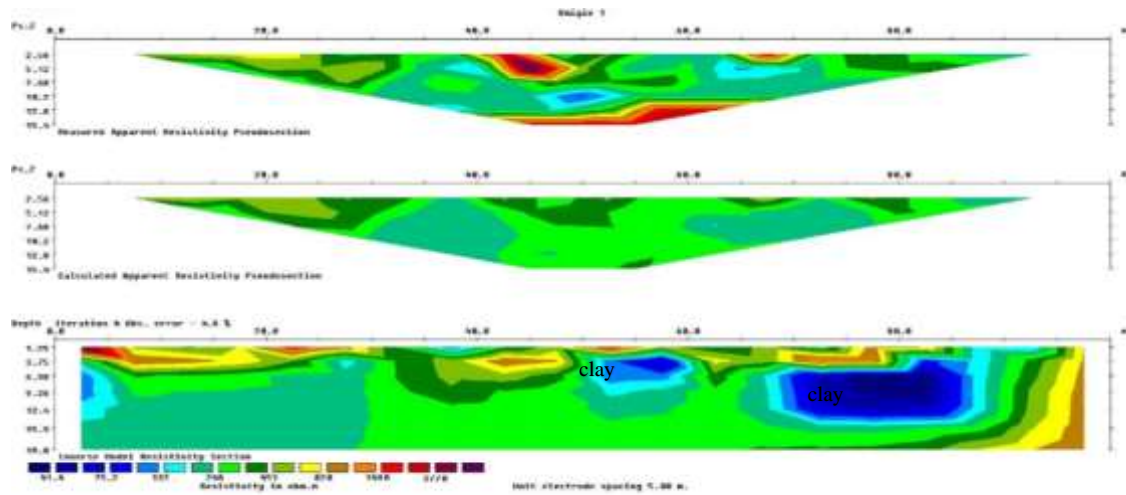
Figure 5a: 2D model of profile 1 at Omigie

Figure 5a shows model of survey profile 1 at Omigie. It displays values of resistivity readings from 248 Ωm to 1490 Ωm from the surface up to about 3.75 m depth from distance 0 m to 80 m length along the profile shows a sandy formation. However, within this sandy formation is another zone having low resistivity range (41.4-137) Ωm at 65 m to 85 m via the profile length to a particular depth 6.38 m to 19.8 m this range is probably made up of clay formation.

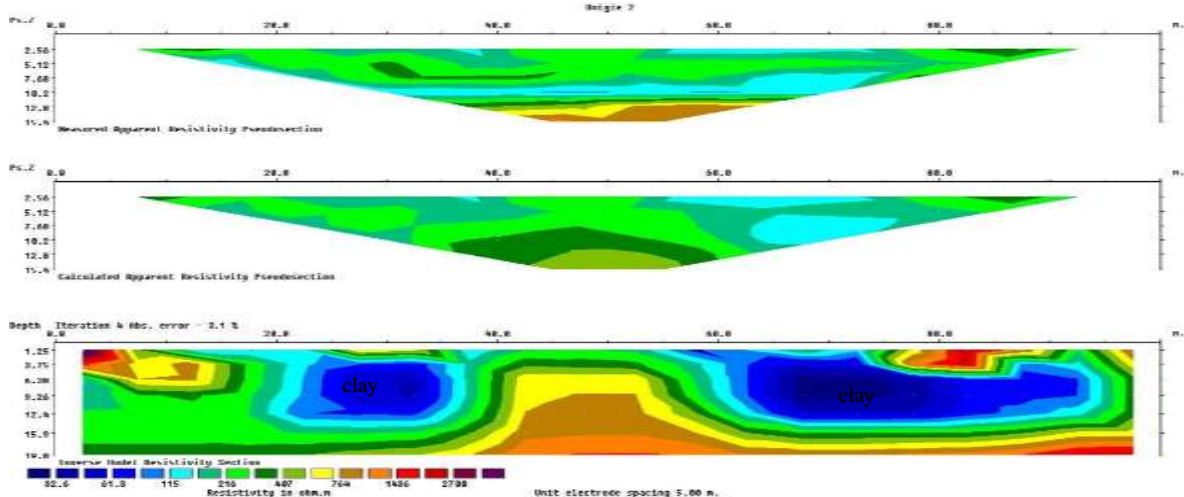
Figure 5b: 2D model of profile 2 at Omigie

Figure 5b shows model of survey profile 2 at Omigie. This profile has a large section with resistivity range 216 Ωm to 2200 Ωm at distances 0 m to 20 m, 40 m to 60 m, 90 m and above along the spreads to depth of 1.25 m to 19.8 m. its indicates that sandy formation can be found in this formation. Another region of low resistivity varying between 32.6 Ωm and 115 Ωm at the top from 20 m to 40 m, and 60 m to 90 m along the profile and to 1.24 m and 12.4 m in depth from the top soil. It is probably a clay sand formation at this position of the model.

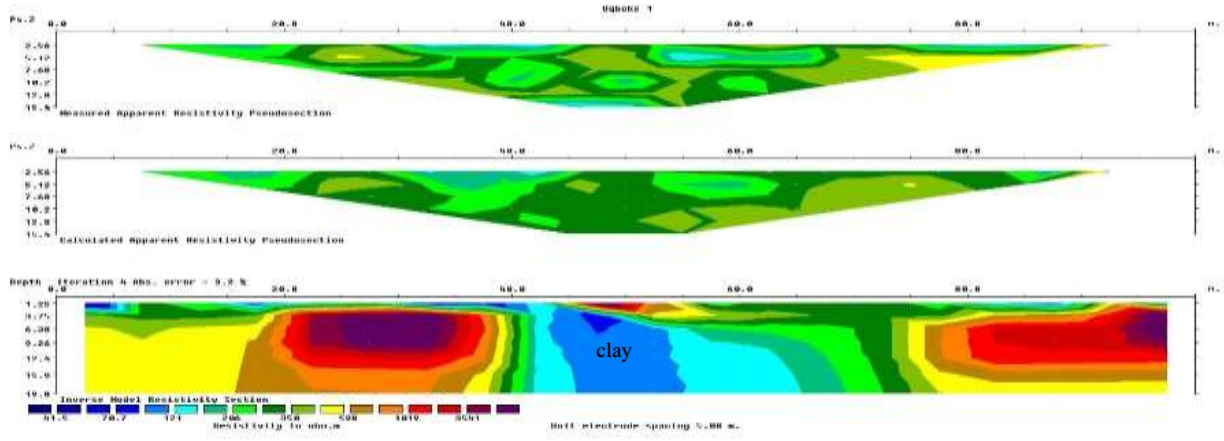
Figure 6a: Result of 2D of profile 1 at Ugboke

Figure 6a is the model of survey profile 1 at Ugboke. Regions of low resistivity range of 41.5 Ωm to 286 Ωm , at 1 m, 20 m, 40 m and 80 m respectively along the profile to a depth of 1.25 m on the surface of the profile. It is probably a mixture of clay and water. Below this position is resistivity range from 286 Ωm to 3541 Ωm at depth of 3.75 m to 19.8 m. It is observe to be sandy formation which might have spread from 0 m to 40 m and 60 m to 90 m along the profile length.

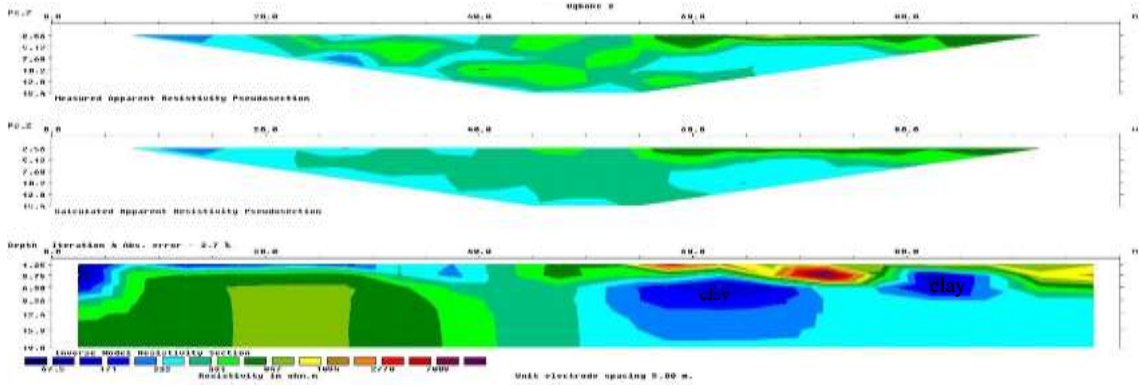
Figure 6b: 2D model of profile 2 at Ugboke

Figure 6b shows model of survey profile 2 at Ugboke. This profile also have regions of low resistivity, with interval 67.5 Ωm to 232 Ωm and found to be sandy clay formation. This spreads from 0 m to 40 m with depth 1.25 m to 6.38 m from the top and also from 50 m to 80 m and above. This profile has resistivity from 391 Ωm to 7809 Ωm , at 0 m to 40 m spread along the surface to a depth of 19.8 m from the top. At 50 m to 80 m and above also with depth 1.25 m to 6.38 m. This was found to be sandy formation.

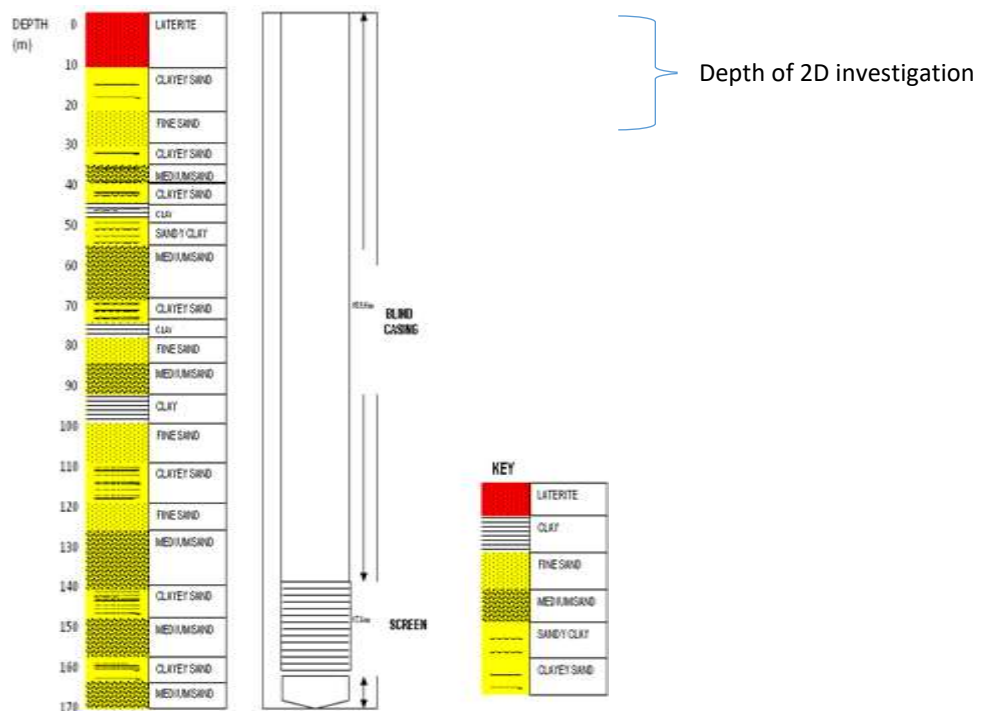
Figure 7: *Lithology Section of Odighi Borehole log.*

Validating this results with figure 7, we compare the lithology with that of a standard borehole log drilled 50 m from one of the survey location at Odighi community which show that there are similarities in the lithology sections with depth of the surveyed locations and the borehole log.
